GEAR FAILURES

THIS DOCUMENT HAS BEEN PREPARED BY THE CATERPILLAR COMPANY AND IS TO BE USED TO HELP FAMILIARIZE OUR SALES PERSONNEL WITH DIFFERENT TYPE OF GEAR FAILURES. THIS DOCUMENT IS NOT INTENDED FOR REPRODUCTION OR DISTRIBUTION TO OTHERS AND SHOULD BE TREATED AS PROPRIETARY INFORMATION AND USED FOR COMPARISONS AND REFERENCE ONLY.

ANALYZING GEAR FAILURES

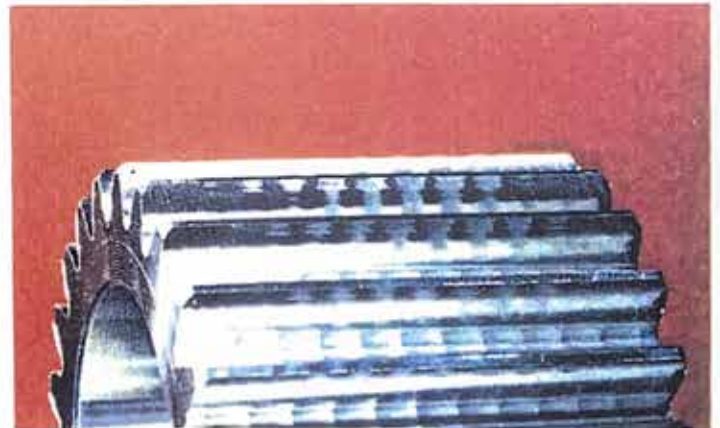
Figure 2 Hob marks

1. Hob Marks. This initial cutting operation produces longitudinal marks which can be seen on some gears in the root area. Normally, these marks are removed from the surface by a finishing operation such as shaving. Occasionally, the finishing operations do not remove all the hob marks. The longitudinal gouges that remain (Figure 2) are not desirable, but only in rare instances do they contribute to gear failures.

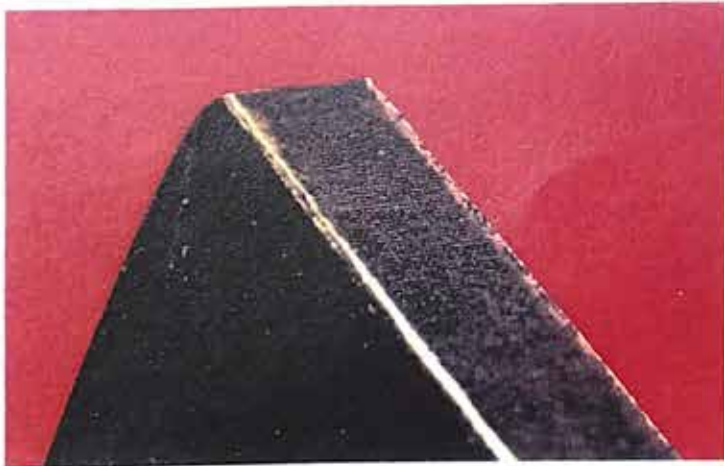
Figure 4. Lipping.

3. Lipping. Another usually harmless fault, but one which is often mistaken for an indication of harmful plastic yielding or plastic wear, is "lipping", shown in Figure 4. Lipping is caused by the use of a dull shaving cutter in the finishing operation. You must be careful to distinguish between harmless lipping and the type of lipping which does indicate metallic flow during operation. Look carefully on both the forward and reverse sides of the tooth. In harmless lipping, the "lips" are formed to the same height on both sides. In plastic yielding there will be a ridge on the most often or heaviest loaded side of the tooth and there may be evidence of metal flow along the ends of the tooth. The "lips" at the tip will be of uneven height.

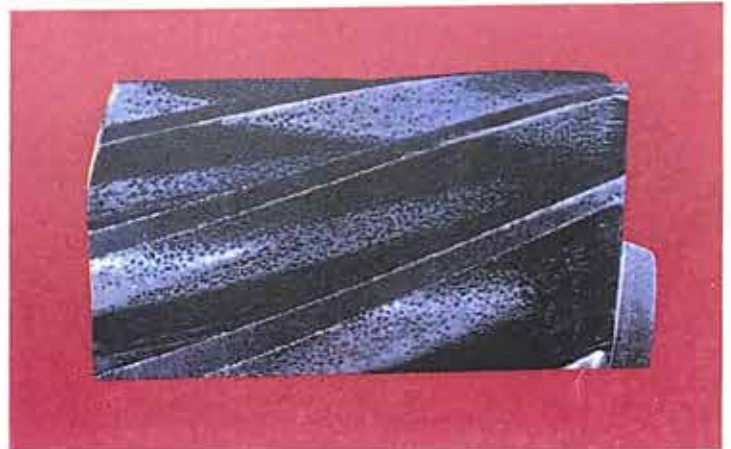
Figure 5. Lubricant or corrosive pitting

Lubricant or corrosive pitting is illustrated in Figure 5. It is characterized by a large number of very small pits, evenly distributed over the working surface of the gear. These pits are caused by the moisture affinity of some additives in Extreme Pressure (EP) oils or some other unusually corro-

sive medium. Although pits of this type could be a potential danger after long operation, it is unlikely that harmful pitting starts from any of these small etch marks.

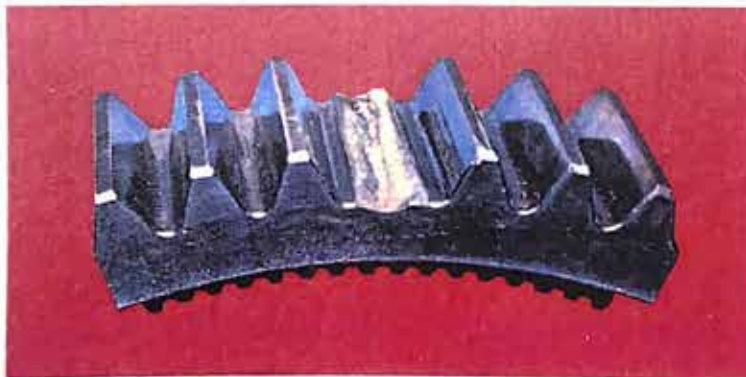
Figure 7. Static fracture.

A fracture following one or a very few high load cycles will often exhibit a hump on the compression side. See

Figure 7. This hump is a severe plastic shear area characteristic in many cases of static fractures on gears and other parts as well. The longer a gear runs before a failure, the smaller the hump will be. Eventually a point is reached when the hump is no longer evident. The fibrous uniform texture of the fracture and the absence of any sign of progressive damage are further indicators of a static fracture.

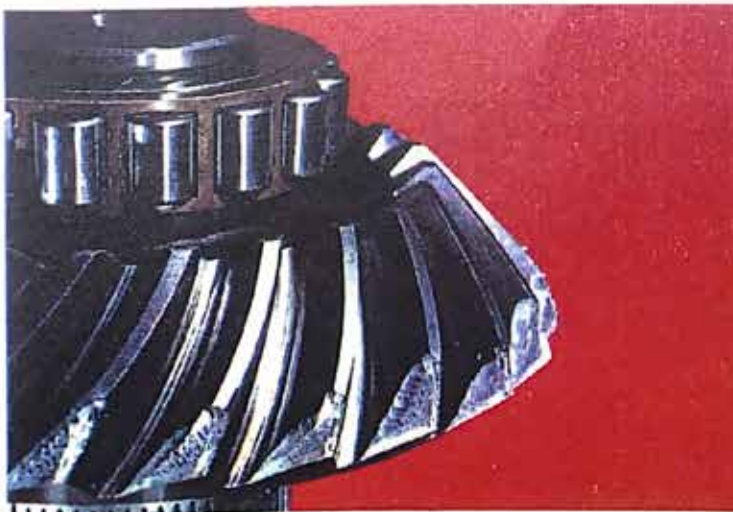
Figure 10. Misalignment fracture.

Figure 10 illustrates fractures resulting from misalignment of the gears. In cases of misalignment, the fracture originates at one end of the tooth and occurs on a diagonal line. Beach marks can be seen on the gear teeth. Misalignment is a common cause of broken teeth on spur or helical gears and bevel gears.

Sometimes misalignment is caused by loose bearings. Loose bearings will result in shaft deflection and ultimately in a gear tooth fracture due to corner loading. It is good preventive maintenance to keep the final drive bearings on a track-type tractor in proper adjustment.

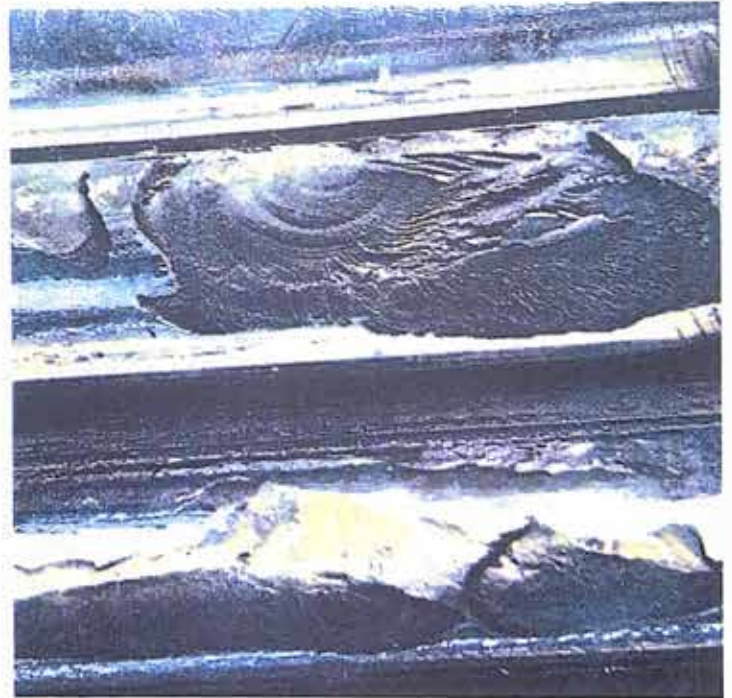
Figure 11. Midtooth fracture caused by pitting.

Quite often a tooth will not fracture at the usual highly stressed fillet area but will break at midtooth (above the fillet). There are two types of midtooth fractures: midtooth fractures caused by "case-crushing" or severe pitting, and midtooth fractures caused by gross nonmetallics or inclusions (material faults beneath the tooth surface). Figure 11 is an example of a midtooth failure caused by pitting, and

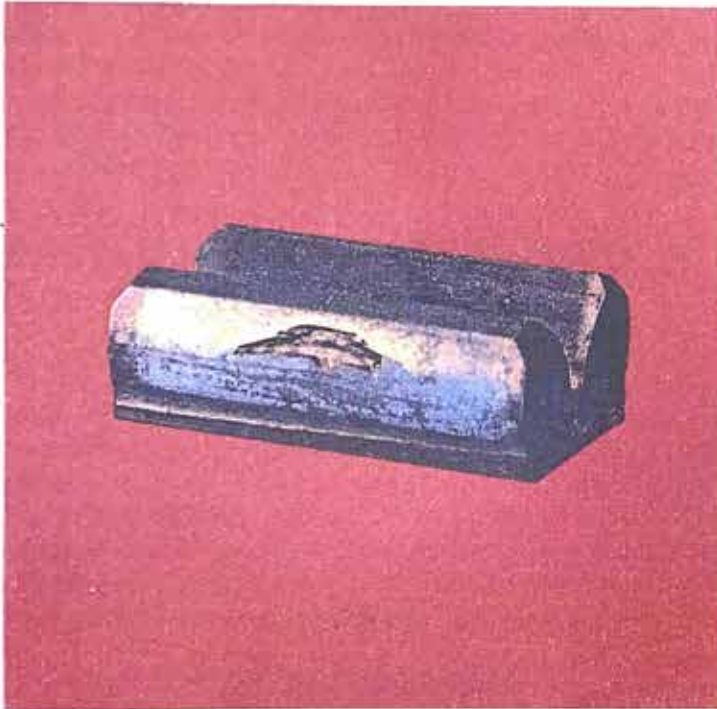
Figure 15. Case crushing.

Case crushing can be identified in its initial stage by longitudinal cracks on the working surface approximately parallel to the pitch line. See Figure 15. Notice that these cracks do not radiate from a single point of origin on the surface. Case crushing is caused by the failure of supporting core material. In the gear pictured in Figure 15, chips have been knocked out of the tooth to show the core failure.

Case crushing occurs most frequently on the larger gears—such as final drive pinions, or bevel gears and pinions. Check for longitudinal cracks in working surface of the tooth.

Sometimes spalling can look like case crushing. However, spalling is identified by flaked out areas and does not have the characteristic longitudinal cracks across the face of the tooth that identify case crushing.

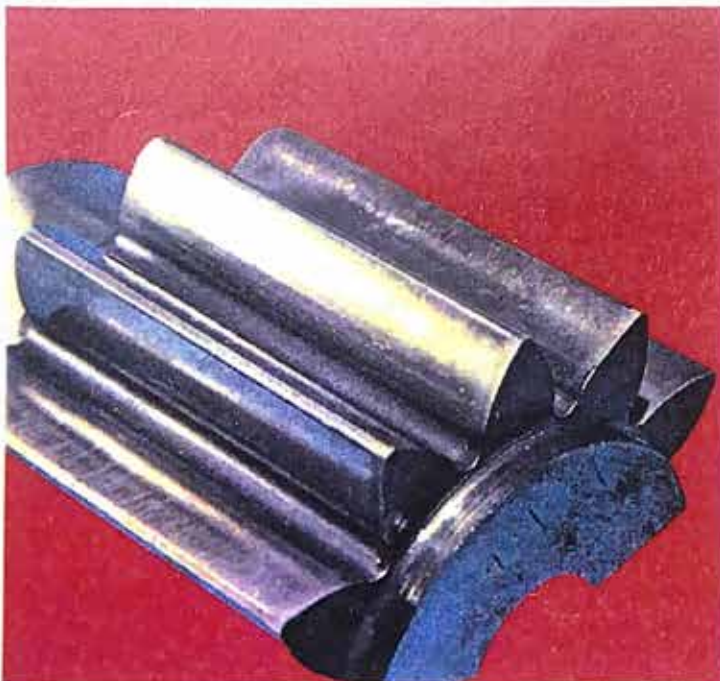
Figure 18. Pitting and wear.

That which results from low-speed operation is shown in Figure 18. In this case the low-speed operation was followed by a load which tended to heal or polish over the severe wear marks. A ridge left on the pitch line was gradually being crushed away to result in pitting and spalling. The load fatigues the metal and finally causes particles to break off.

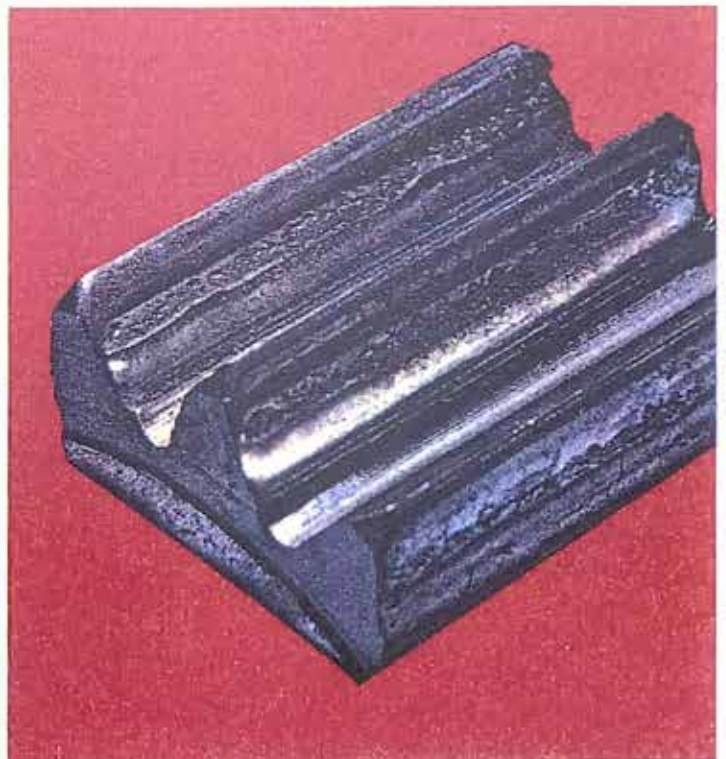
Figure 20. Destructive pitting.

Figure 20 illustrates destructive pitting. This badly pitted gear would be noisy in operation. Additional pitting would probably cause the tooth to break because the unpitted areas of the surface would be insufficient to carry the load. This gear also shows a slight discoloration which means it may have become too hot which reduced surface hardness and allowed pitting to start.

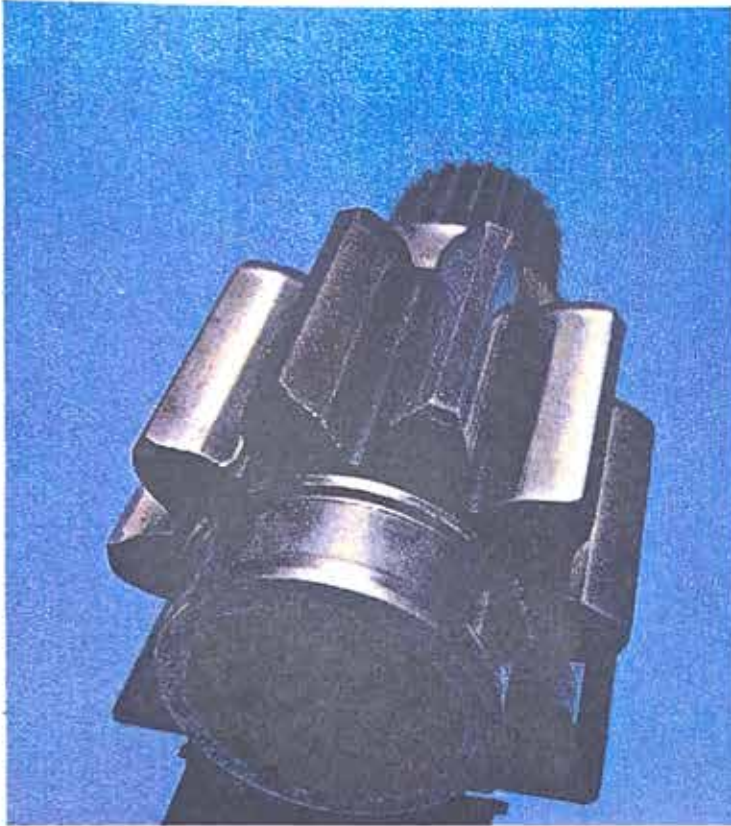
Figure 27. Abrasive wear.

Abrasive wear characteristically has a very satiny matte surface appearance. See Figure 27. To detect this, use a mirror to reflect the light from the surface of the gear. You can often see flat, worn areas that interrupt the tooth profile. It begins at the lowest point of single tooth contact, ends at the pitch line, and begins once more at the pitch line to end at the highest point of single tooth contact. The wear follows this pattern because of the high loads in these areas and the degree of sliding taking place. Prominent ridges at the pitch line and near the lowest point of contact identify abrasive wear.

These abrasive wear ridges carry more than their share of the load . . . more than if the entire surface were bearing the load. In any situation where the bearing area decreases but the load remains the same, the unit stress, or pounds per square inch, increases. If you could examine this gear in Figure 27 closely, you would see that the surfaces of the gear teeth have been worn away, leaving a ridge at the pitch line.

Abrasive wear is identified by a satiny lapped appearance and irregular tooth profile. Since it is caused by foreign material in the lubricant, check for sediment in the gear compartment regularly.

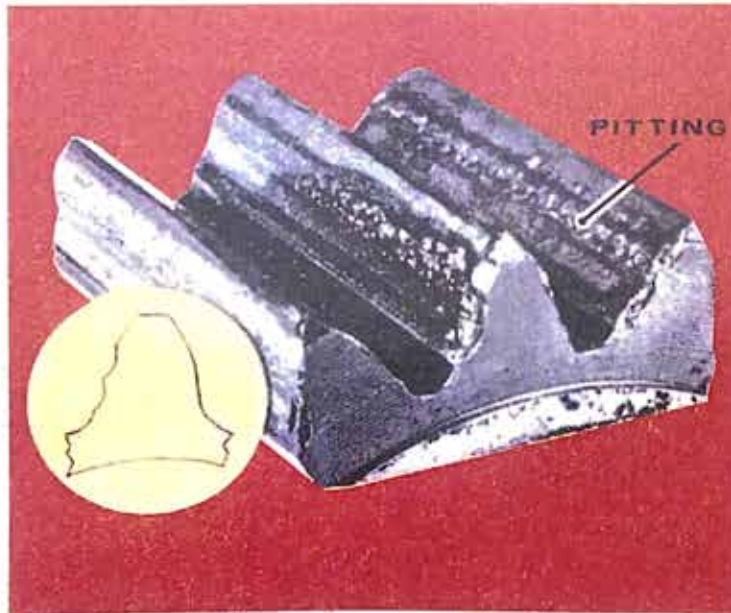
Figure 28. Advanced stage of abrasive wear.

Figure 28 represents an advanced stage of wear. It is a typical example of what very small quantities of abrasives in the oil can do. The wear is extremely severe from the L.P.S.T.C. to the pitch line, and again from the pitch line to the H.P.S.T.C. Note that the wear is not confined to one area of the tooth face but extends the full width. The reason for this wear pattern is that the sliding action between mating gear teeth occurs above and below the pitch line. Abrasives in the lubricant act as a lapping compound.

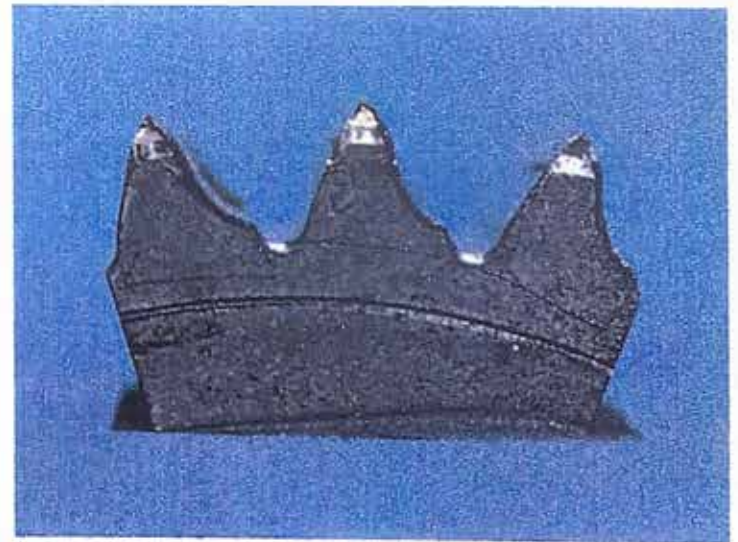
Figure 29. Plastic yielding

Plastic yielding is a severe flow of surface material generally resulting in lip ledges forming on the ends and/or tips of the gear teeth. These lips are usually of uneven height.

Plastic yielding may occur on gears subjected to heavy continuous loading or to gears subjected to intermittent heavy loads which act like hammer blows. An example of the latter type are engine timing gears, which have been subjected to vibratory loads or dynamic loads with severe impact. It sometimes occurs on gears of low hardness... very rarely on hardened gears. If plastic yielding does occur on a hardened gear, it is the result of poor heat treatment. Figure 29 shows this type of extrusion of metal surfaces.
